TWO-STAGE POTASSIUM TEST TURBINE

Volume IV

Materials Support of Performance
and Endurance Tests

Prepared under Contract No. NAS 5-1143 by
GENERAL ELECTRIC
Cincinnati, Ohio

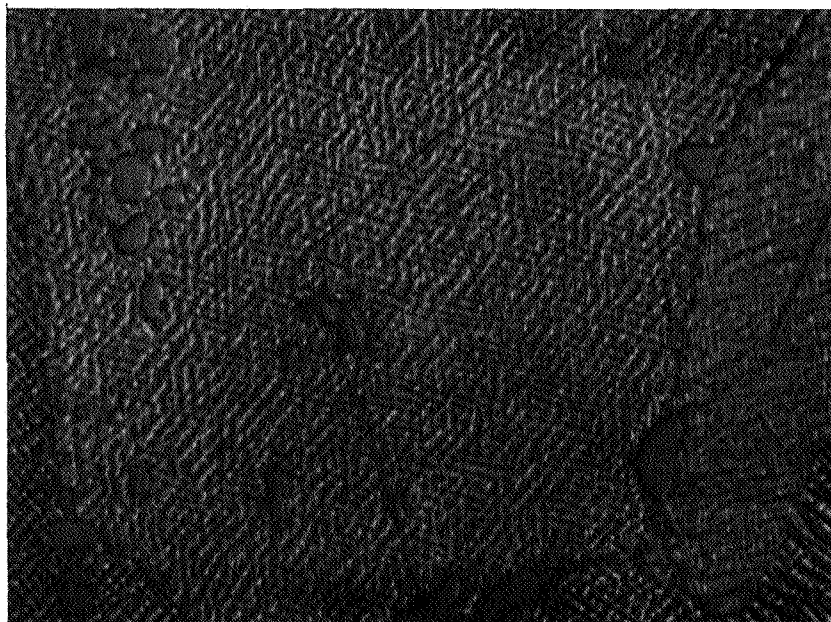
Figure 7. First Stage U-700 Blade Dovetail After 2000-Hour Endurance Test Showing Concentration of Accicular Structure Presumed to be Sigma Phase. (B322311)

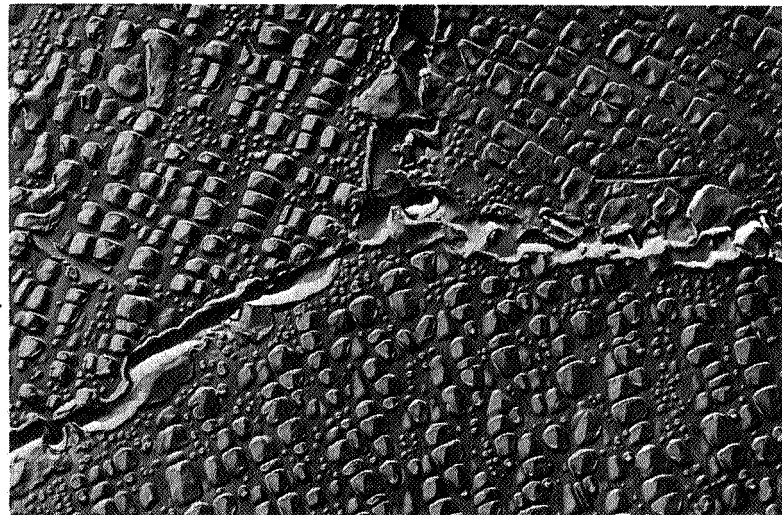
Figure 5. Electron Micrograph of a U-700 First Stage Blade After 2000-Hour Endurance Test at Approximately 1450°F. Note Coalescence of Gamma Prime Precipitate Within Grains and Growth of Intergranular M₂₃C₆ Carbides. (B3215)

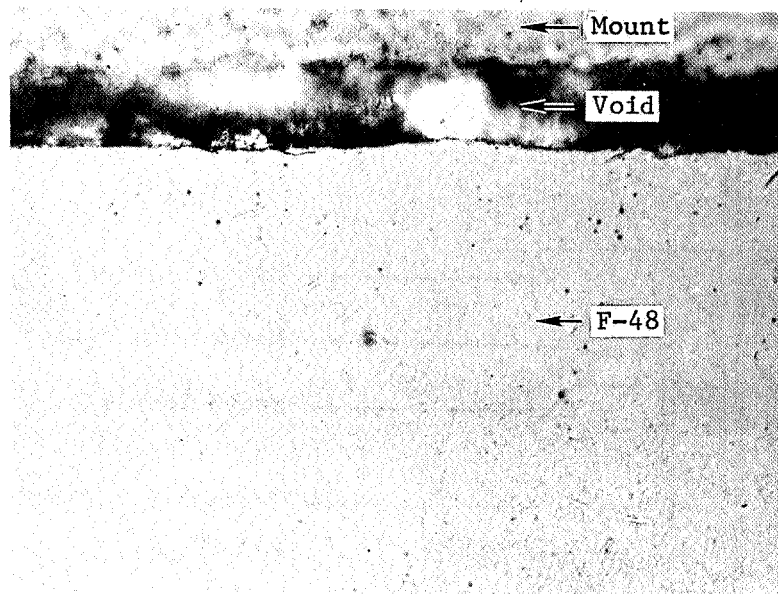
Metallographic examination of the surface of the refractory alloy probe specimens revealed subtle indications of contamination of the F-48 alloy in the form of a new phase which is apparently non-metallic in nature. It could be seen in the as-polished conditions and became more apparent when etched with 60% Glycerine - 20% Hf - 20% HNO_3 etchant. The phase is best defined by an electrolytic anodizing treatment, as is shown in Figures 18 and 19. The pale yellow color of the phase is similar to that observed by Harrison and Delgrosso⁵ in the low pressure oxidation of Cb-1Zr and which they identified as CbO. A

Figure 18. Contaminated Surface of F-48 Probe Specimen from Station One After 12 Hour Exposure to Inlet Potassium Vapor During Turbine Performance Test. (A320113)

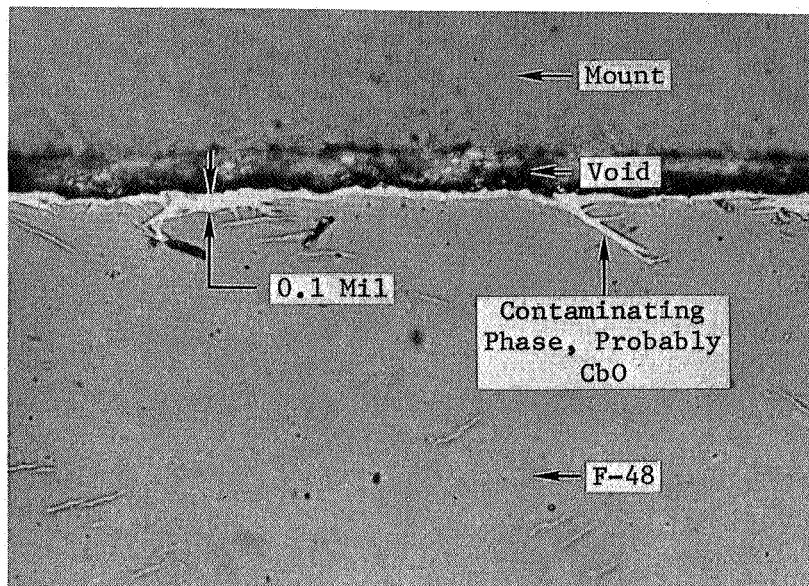
Figure 19. Contaminated Surface of F-48 Probe Specimen from Station One After 56 Hour Exposure to Inlet Potassium Vapor During Turbine Performance Test. (A320614)

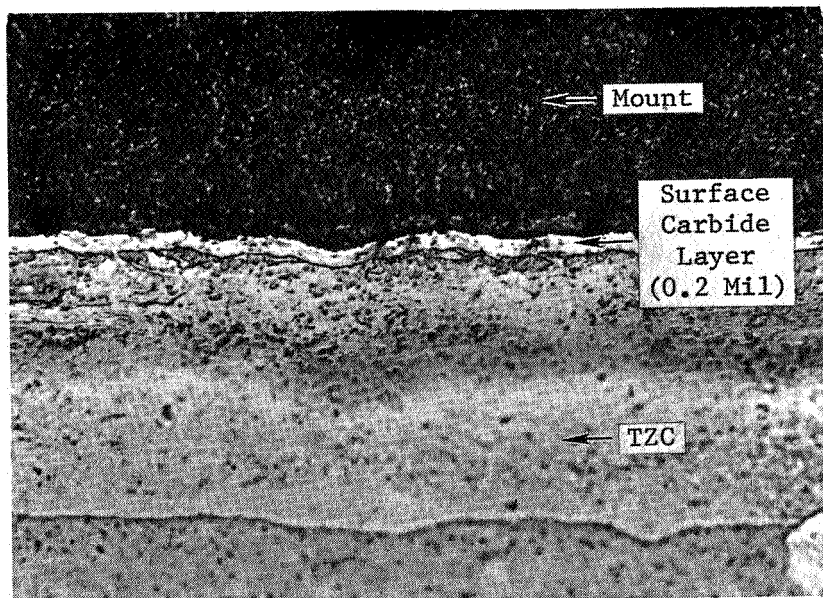
Table VIII shows the tensile test results of these TZC test specimens; they exhibited no ductility at temperatures as high as 650°F, which is the maximum reasonable temperature for turbine preheat. Ductile failure occurred at 1200°F. Figure 20 shows the presence of 0.0002-inch thick carbide film which was identified by x-ray diffraction as Mo_2C and MoC. Carbon analysis of a 0.030-inch thick section from the end of a tensile specimens indicated a carbon content of 2200-2500 ppm compared to an original vendor analysis of 1470 ppm.

Figure 20. Carbide Formed at the Surface of TZC Exposed for 100 Hours at 1400°F in Liquid Potassium Containing Carbon. (A890111)

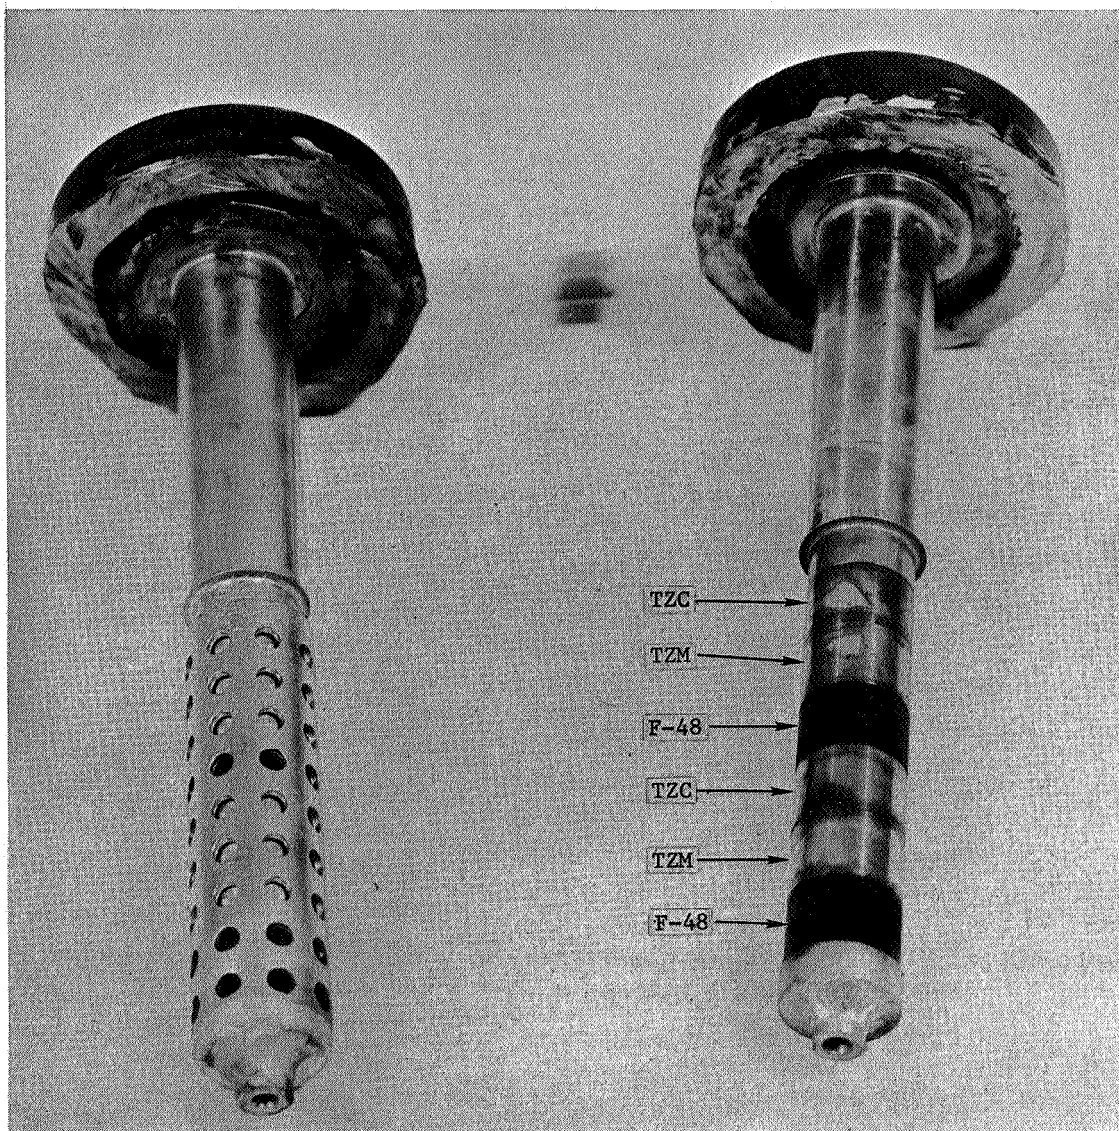
Figure 21. Refractory Alloy Specimen Probes from Station One, Left, and Condenser, Right. (Note Darkening of F-48 Specimens)
(C65032822)

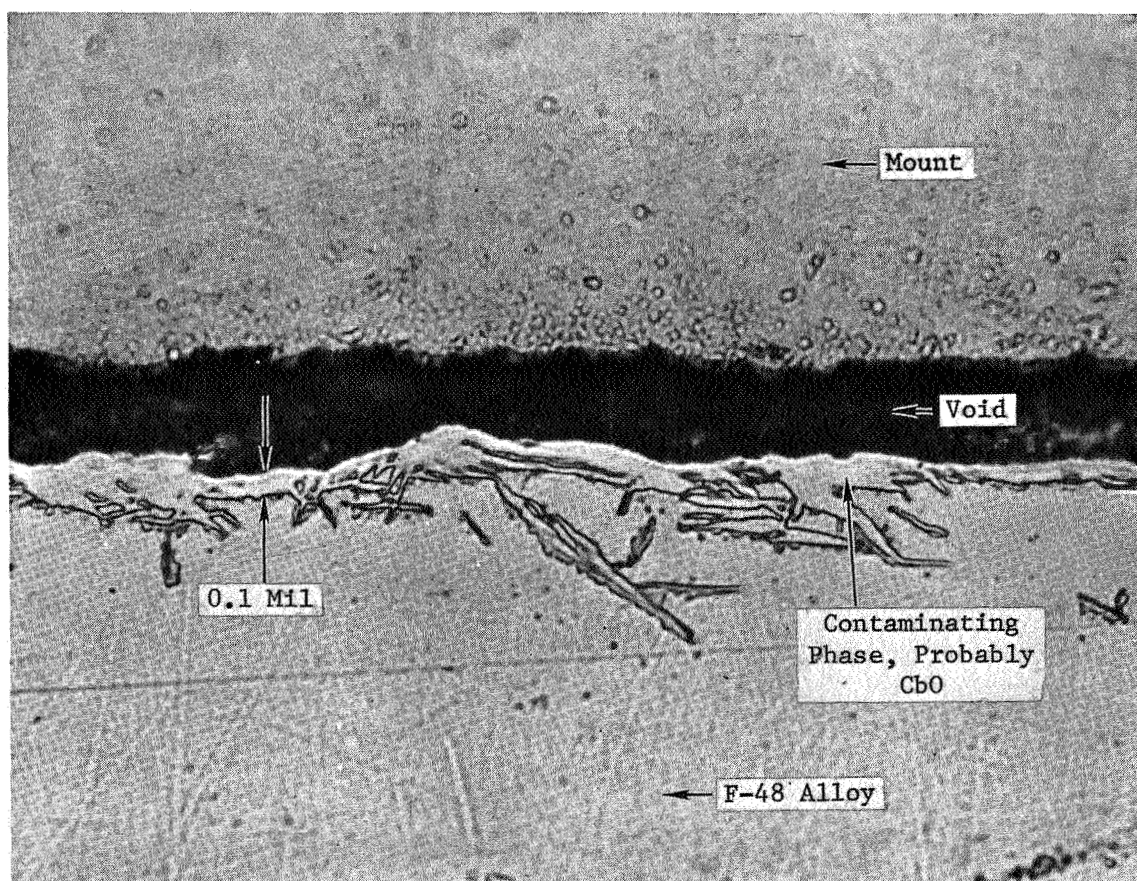
Metallographic evaluation of the refractory alloy specimens after 254 hours and after 2000 hours of the turbine endurance test revealed interesting structures only in the F-48 alloy. As shown in Figures 23 and 24, the contamination of an F-48 specimen at Station One, which operated at a higher temperature, is more extensive after 254 hours than that of an F-48 specimen taken from a lower temperature location downstream of the turbine. After 2000 hours of testing, the surface contamination was much more extensive at the surface of the F-48 specimen located at the turbine inlet, as shown in Figure 25. The contamination has penetrated well over a mil along grain boundaries. The F-48 specimen located aft

Figure 23. Contaminated Surface of F-48 Specimen from Station One After 254-Hour Exposure to Inlet Potassium Vapor During Turbine Endurance Test. (A930114)

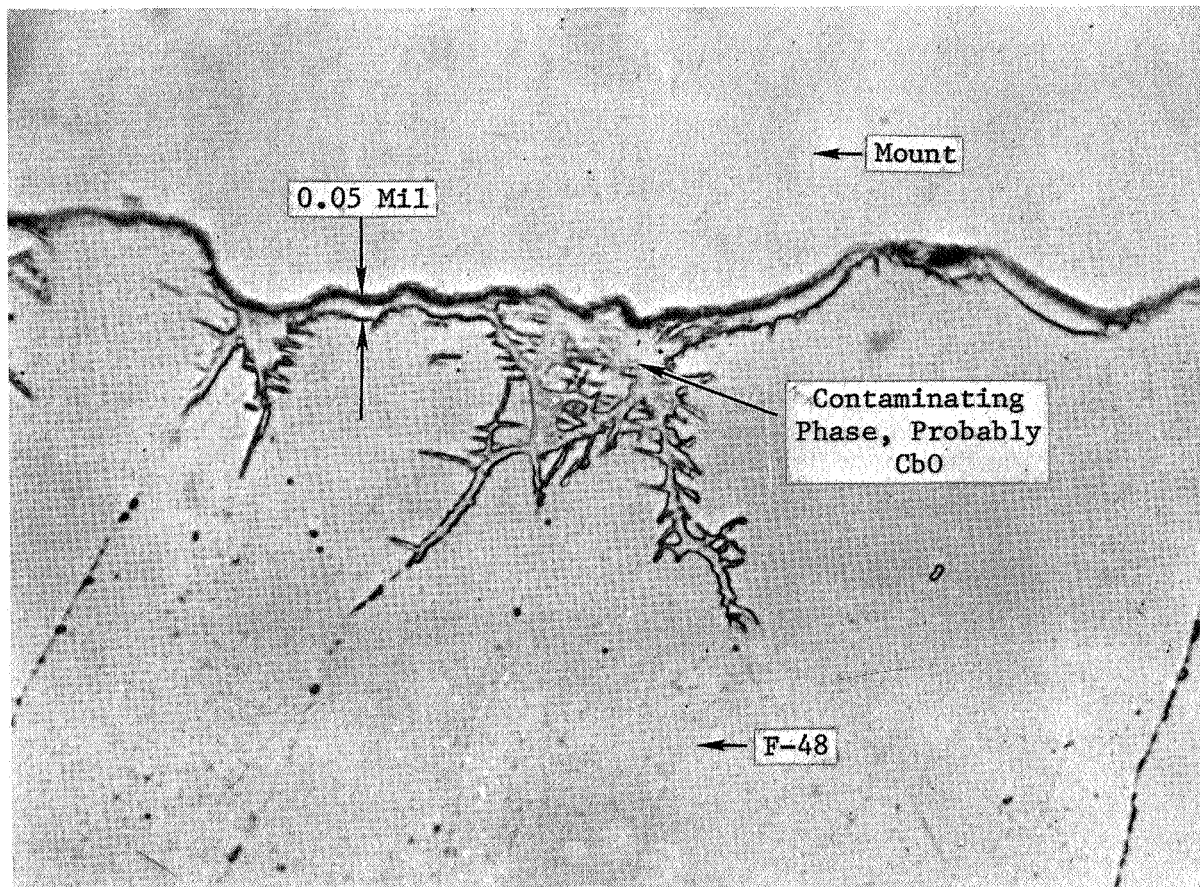
Figure 24. Contaminated Surface of F-48 Specimen from Condenser After 254-Hour Exposure to Exit Potassium Vapor During Turbine Endurance Test. (A930312)

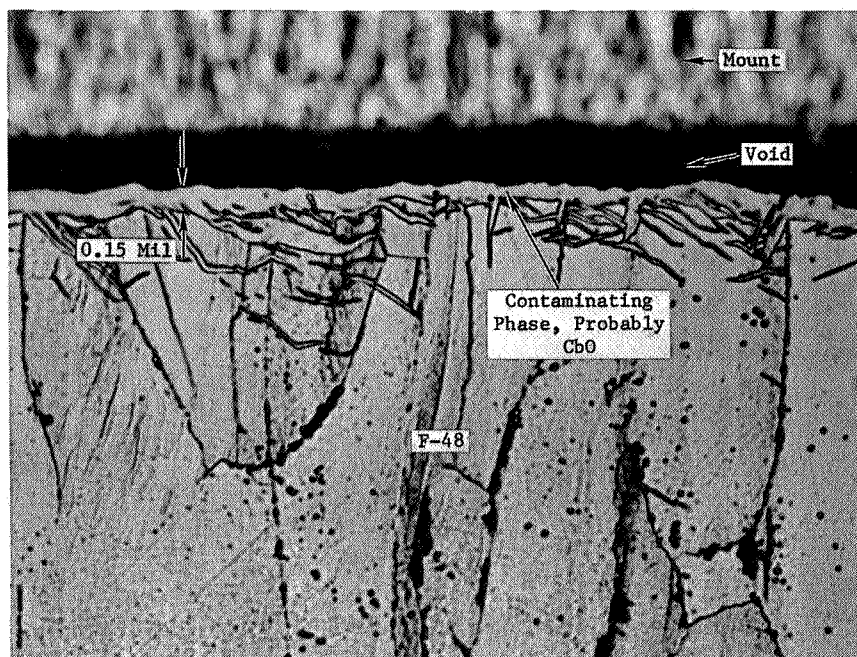
Figure 25. Contaminated Surface of F-48 Specimen from Station One After 2000 Hour Exposure to Inlet Potassium Vapor During Turbine Endurance Test. (B280911)

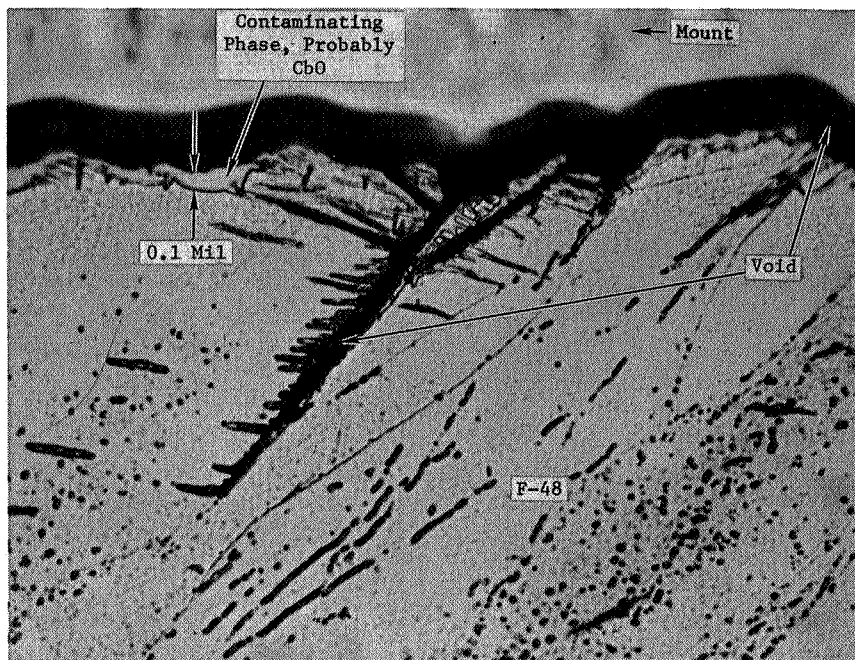
of the turbine does not show this same degree of either extensive surface contamination or of intergranular penetration (see Figure 26).

Figure 26. Contaminated Surface of F-48 Specimen from Condenser After 2000 Hour Exposure to Exit Potassium Vapor During Turbine Endurance Test. (B281212)

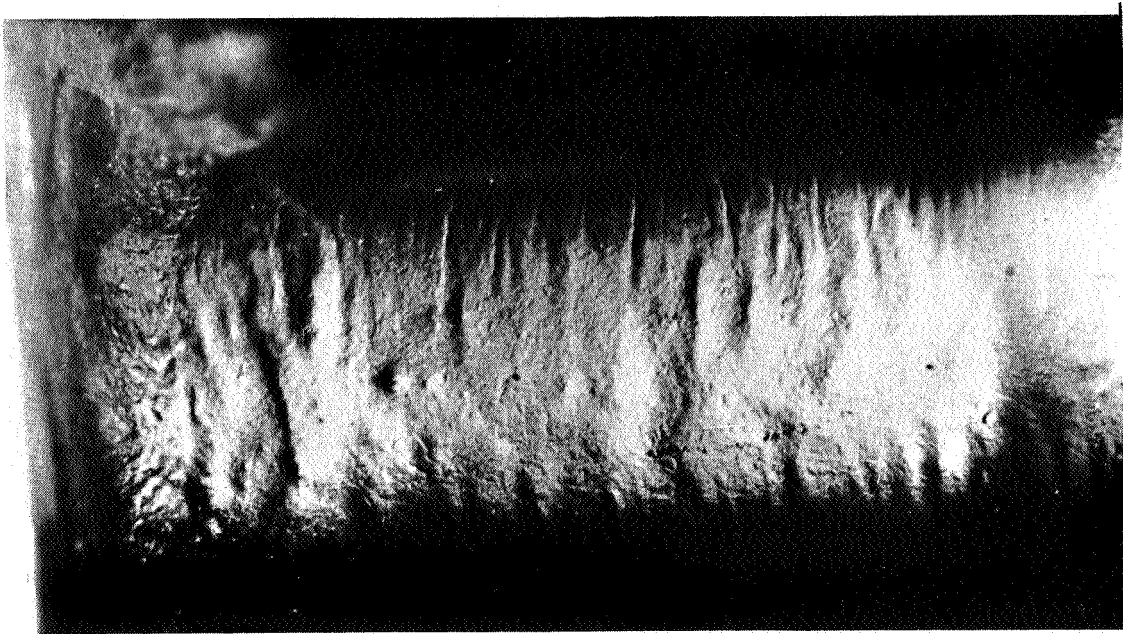
Damage by liquid metal occurred in many places and resulted in the removal of metal from the components. A single set of L-605 nozzle partitions, which were used for all turbine tests, were lightly corroded at their leading edges as shown in Figure 27. The trailing edges of the first stage partitions were corroded by liquid droplets rebounding from the first stage blades and the honeycomb turbine tip shroud was corroded where droplets were slung in a radial direction from the turbine blades; see Figure 28. The damage to the first stage wheel assembly can be seen in Figure 29. Rene' 41 turbine blade fasteners were corroded along the upstream sides of the turbine wheels as seen in Figure 30. Some corrosion occurred along the face of the first stage wheel near the bucket dovetails. Severe solution corrosion occurred underneath the bucket platforms of the first stage buckets as shown in Figure 31. Corrosion patterns on the bucket are shown in Figures 32, 33 and 34. Damage to the second stage was significantly less as indicated by the appearance of these turbine buckets, shown in Figure 35.

Figure 27. Enlarged View of Leading Edge of the First Stage L-605 Nozzle Vane. (C64122369) Mag: 9X

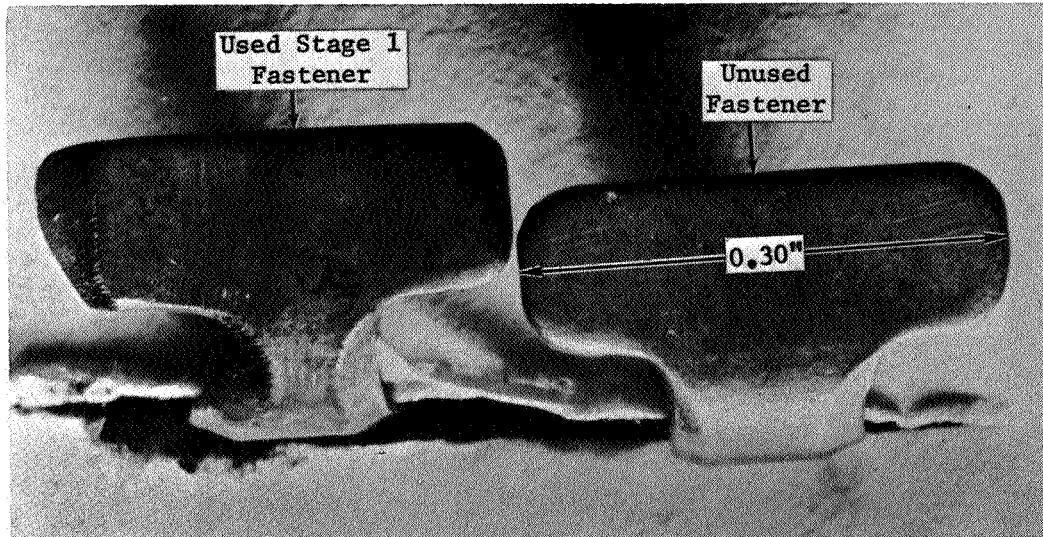
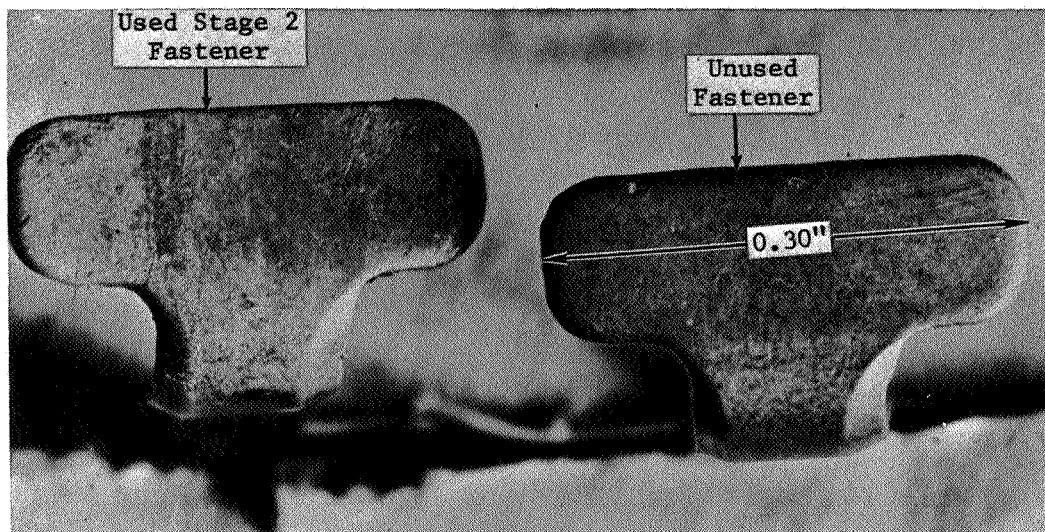
3. Turbine bucket locking strips were increased in thickness for the performance test. These strips failed by strain age cracking in the sharply bent forward radius. This problem was eliminated by using a more generous bend radius and by re-solution treating the fabricated locking strips before installing them in the turbine wheel assembly; the locking strips were aged in place during turbine operation.

Figure 30. Comparison of Blade Locking Strips Before and After 35-Hour Turbine Checkout.

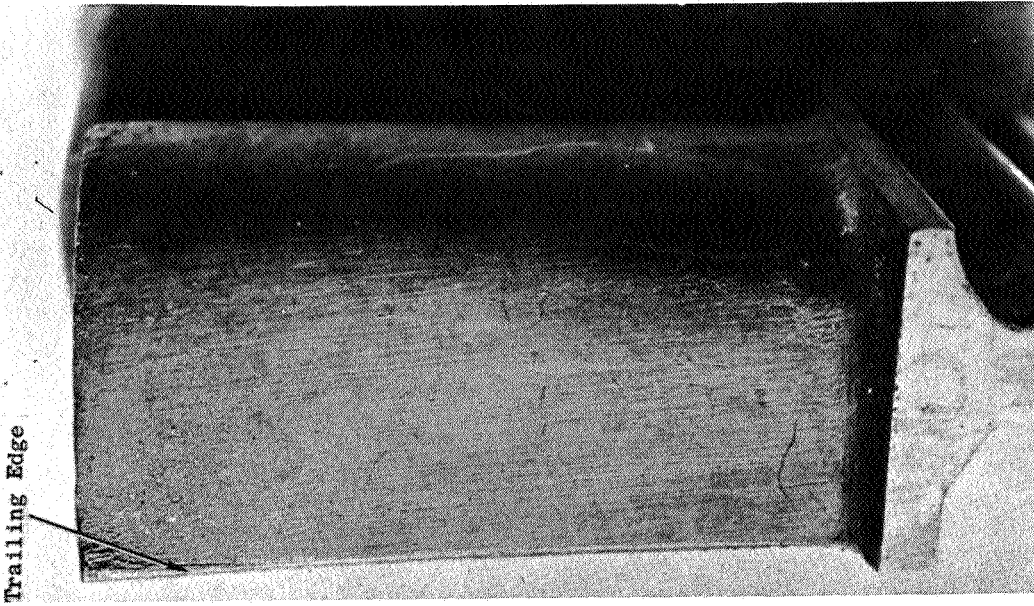
The fire damage to the second stage stator and turbine shroud is shown in Figures 36, 37 and 38. Air entering through a leak in the instrumentation line aft of the first stage turbine wheel produced an internal fire which melted a portion of the second stage nozzle diaphragm and vanes and destroyed a portion of the honeycomb turbine shroud.

Figure 36. Fire Damage in Second Stage Tip Seal During 35-Hour Turbine
Checkout. (C64120413) Mag: 1/2X

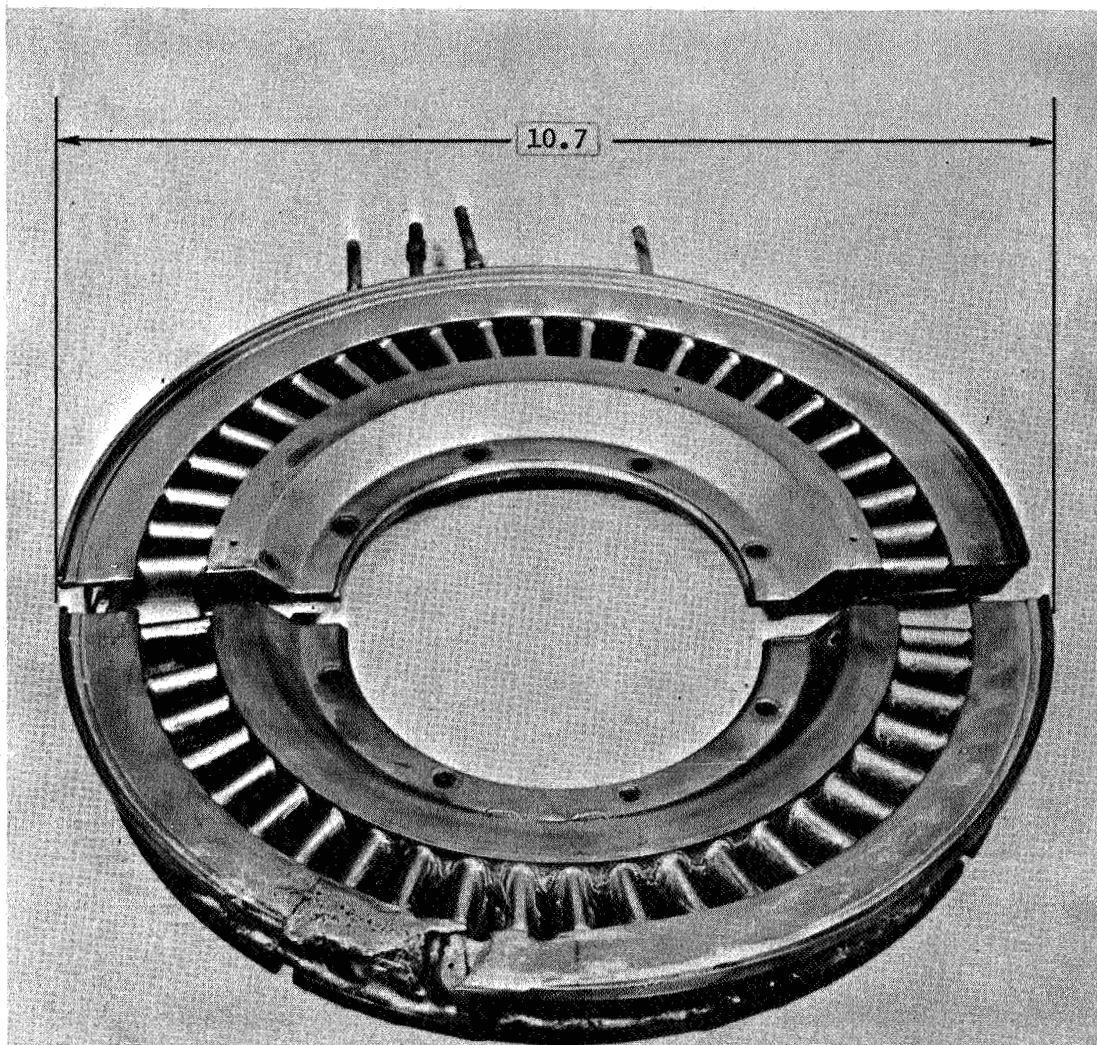
Figure 37. Second Stage Nozzle Diaphragm After Removal from Casing Following 35-Hour Turbine Checkout. (C64121805)

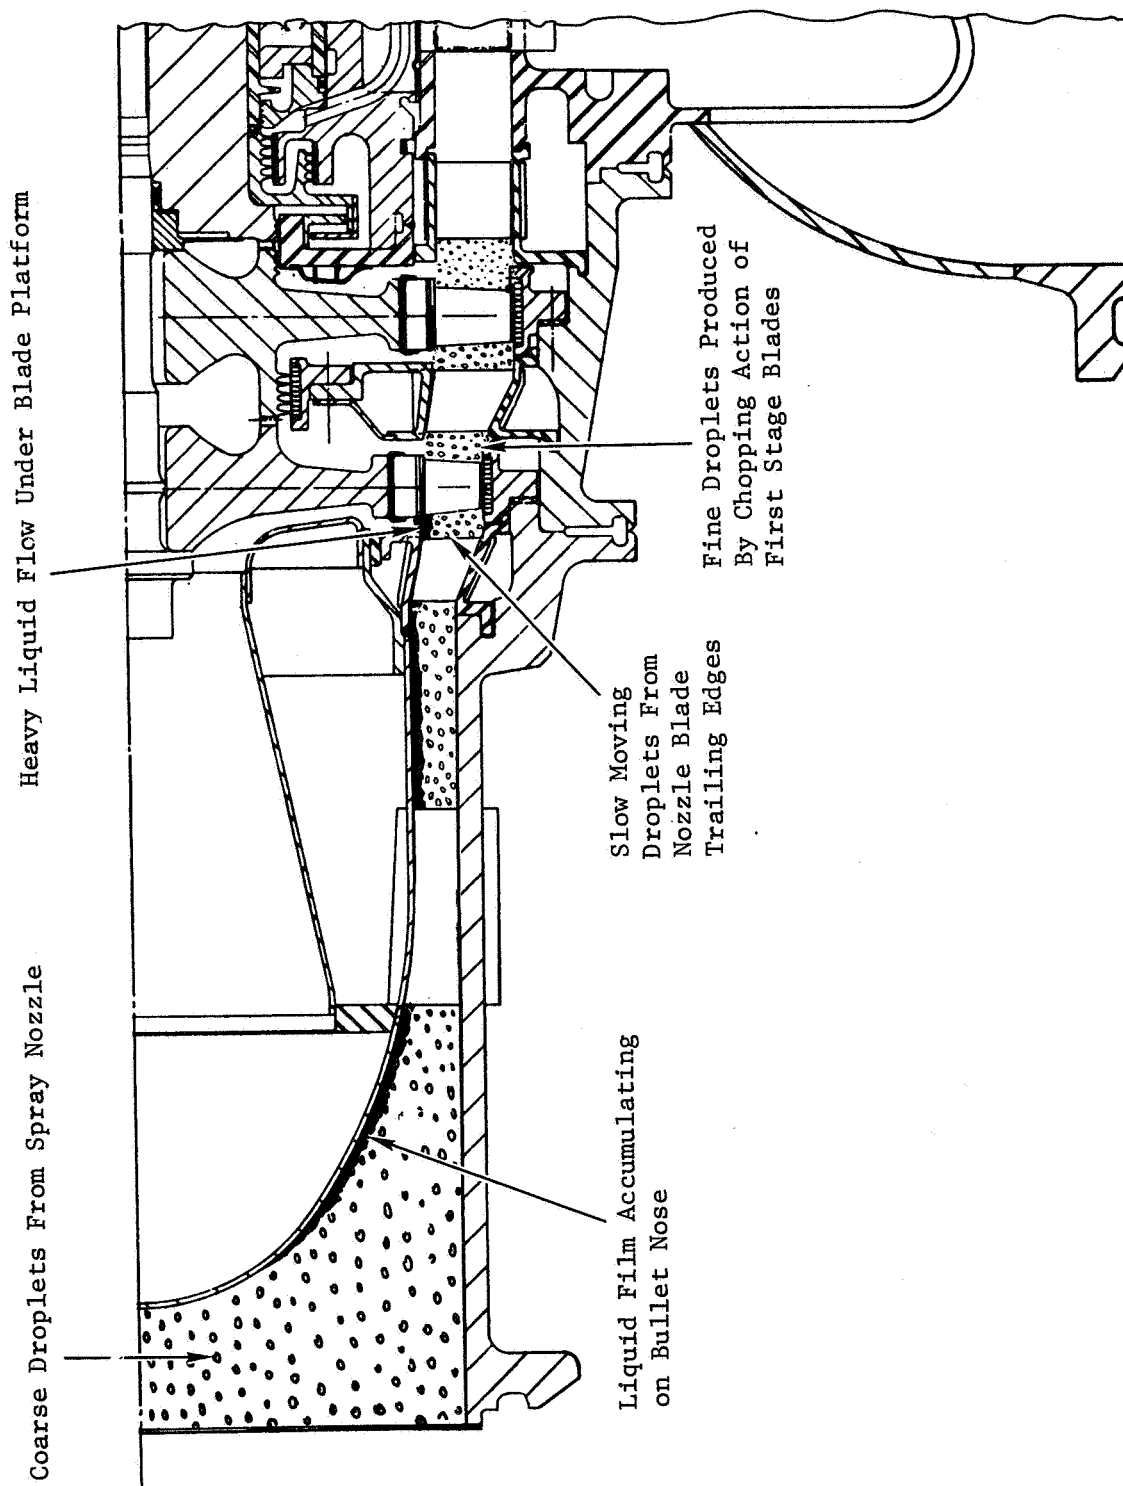
Liquid potassium droplets either carried in the vapor from the boiler or injected into the 8-inch diameter vapor line at the spray nozzle were collected on the bullet nose and flowed through the first stage nozzle partition along the inner band. Other liquid potassium droplets, which did not collect on the bullet nose, passed directly through the nozzle diaphragm; some of these larger droplets collected on the nozzle partitions and left the trailing edge of the partitions as slow moving droplets which were subsequently struck by the convex side of the leading edge of the first stage blades. In all cases, the liquid flow into the turbine appeared to have occurred in fairly large quantities over a limited time as would occur during operation of the spray line system. The distribution of this flow, as deduced from later inspection of the hardware, is shown in Figure 39.

Figure 39. Schematic Diagram of Suspected Flow of Liquid Potassium in the Turbine During Operation of the Spray Line.

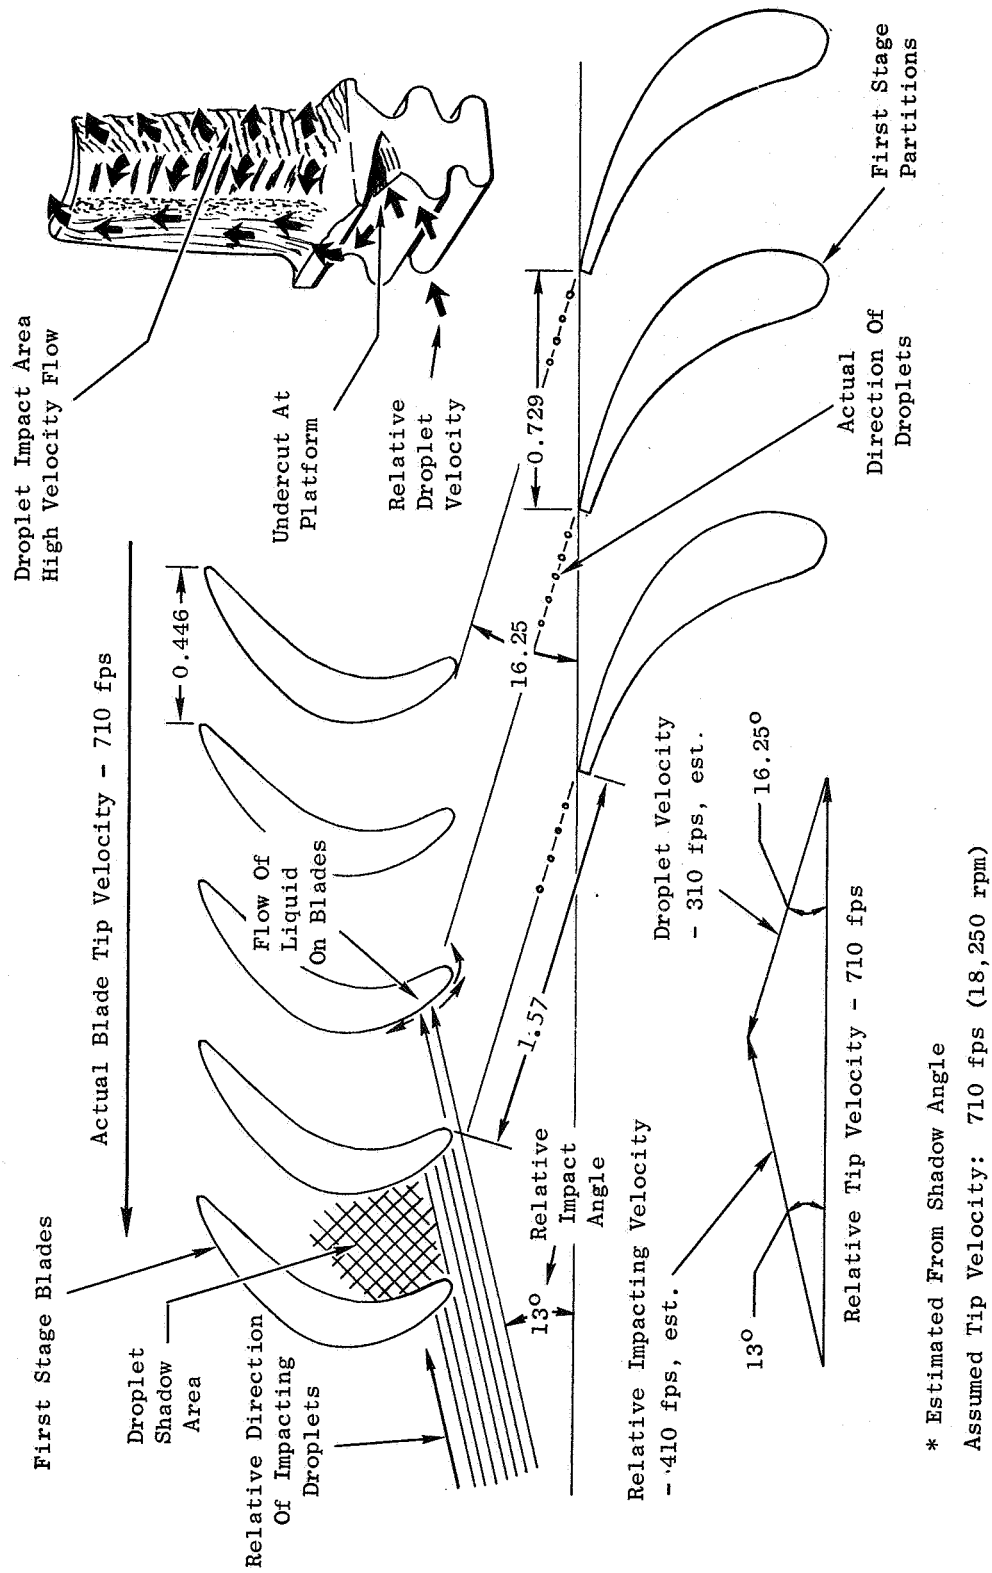
second, the blade tip velocity. The actual droplet velocity was appreciable as indicated by the fact that impacting occurred over an area along the convex airfoil surface. Figure 40 also shows the method used to estimate the relative angle of impacting droplets; the velocity of the droplets from the nozzle blade trailing edges had increased to about 310 feet per second at the time of impact and the droplet impacting velocity relative to the blade was approximately 410 feet per second, which was appreciably less than the blade tip velocity of 710 feet per second. Liquid metal in the impact area flowed forward under high contact pressures due to both the blade momentum and the impact of liquid potassium droplets. Here, high velocity solution corrosion appeared a likely explanation for metal removal as evidenced by the rivulations, previously noted in Figure 32, which flow toward the leading edge. A narrow axial area appeared on the convex side of the blade just aft of the aforementioned rivulations where the impacting liquid appeared to flow rearward to a point which was shadowed from the impacting droplets by the preceding blade. A radial line of pits on the convex side of the blade marked the point at which the high liquid contacting forces produced by the impacting droplets no longer existed; from the line of pits aft, evidences of radial liquid flow on the convex surface were noticed. These pits may represent a form of cavitation corrosion in which pulsations in liquid flow might accelerate corrosion. Cavitation corrosion is also suspected along the blade trailing edge where pits were noted as seen in Figure 41. Cavitation corrosion may have occurred also at those places on the blade where, for aerodynamic reasons, alternate vaporization and condensation may have occurred or where eddying accumulations of liquid metal gathered for aerodynamic reasons.

Figure 40. Estimated Droplet Velocity Vector Diagrams and Impacting Droplet Flow Conditions During Liquid Potassium Spray Injection Into the Turbine.

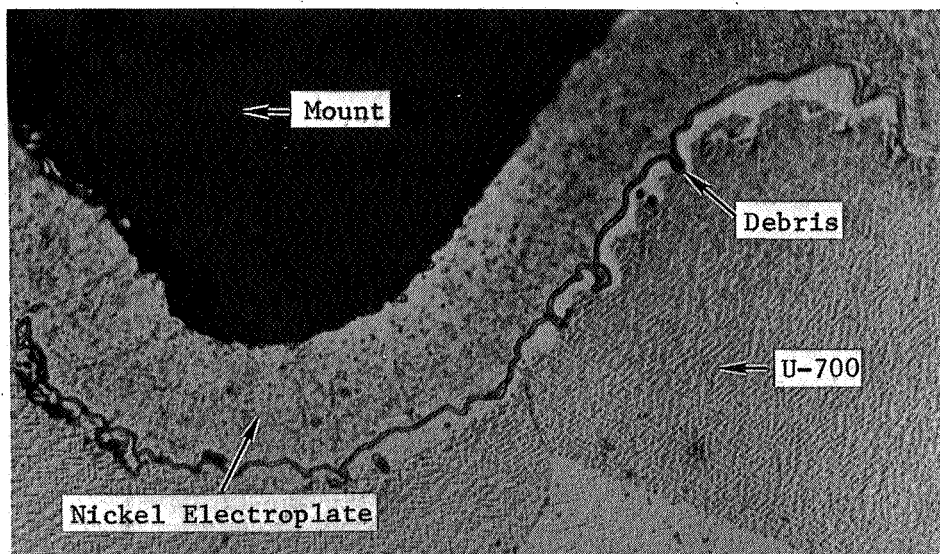
Figure 45. Optical Photomicrograph of Area of Electron Microprobe Analysis, Convex Surface of Stage One Blade.

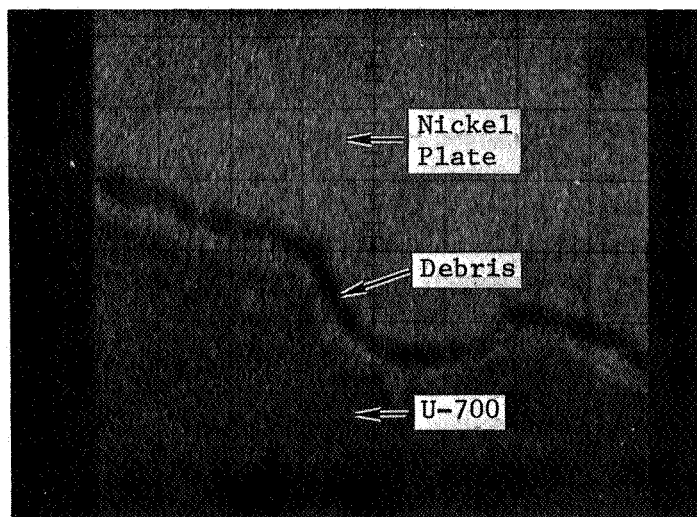
Figure 46. Electron Microprobe Oscilloscope Plot of Nickel Trace at the Convex Surface of a First Stage Blade.

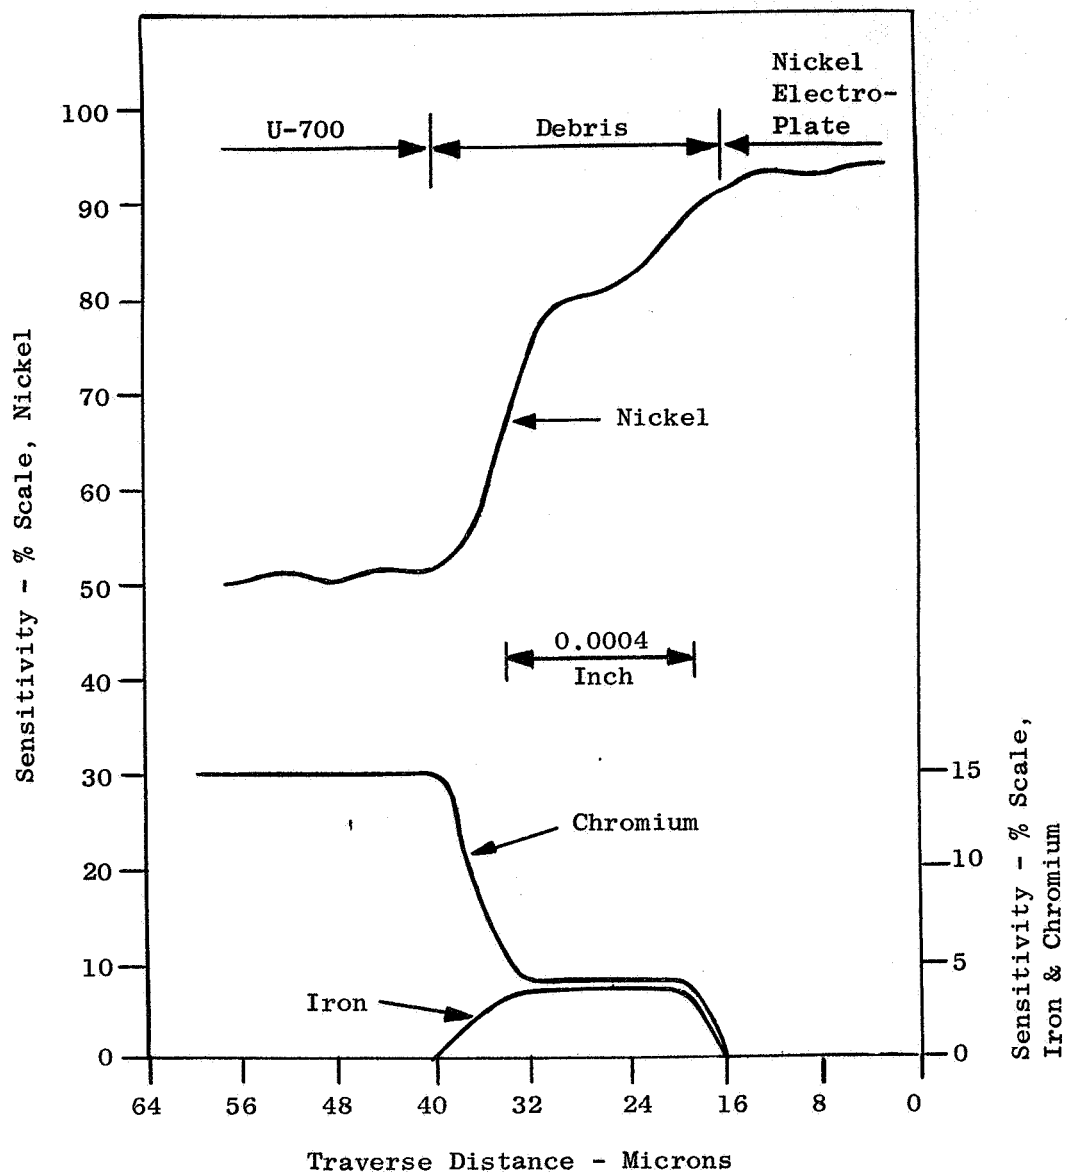
Figure 47. Electron Microprobe Beam Traverse of U-700 Blade.

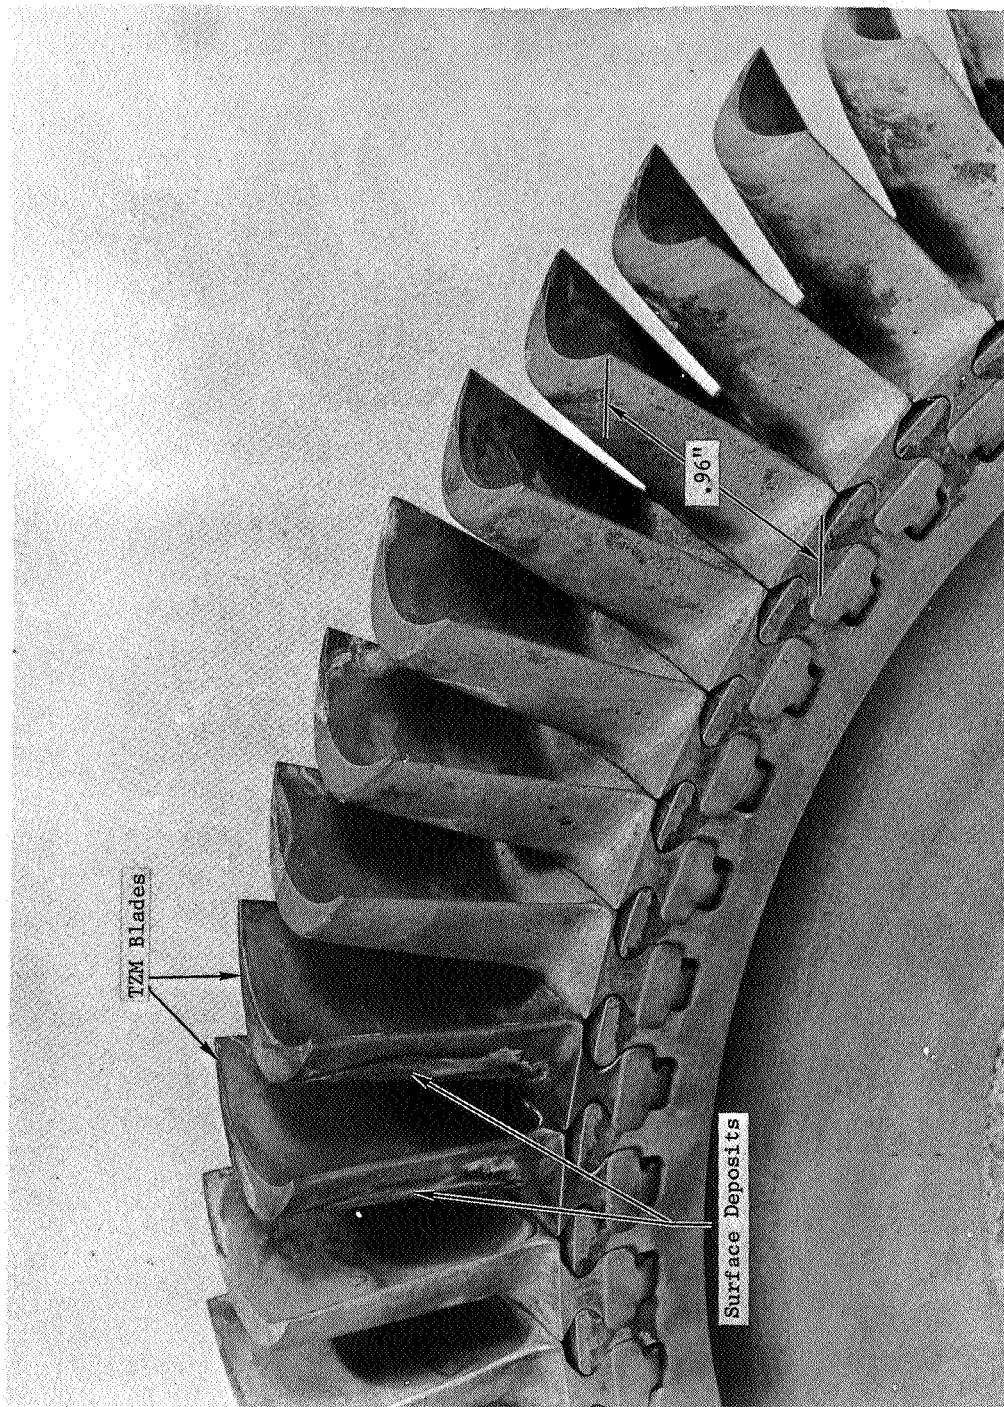
Figure 49. Second Stage Turbine Wheel Assembly After 2000 Hour Endurance Test. (C65123016)

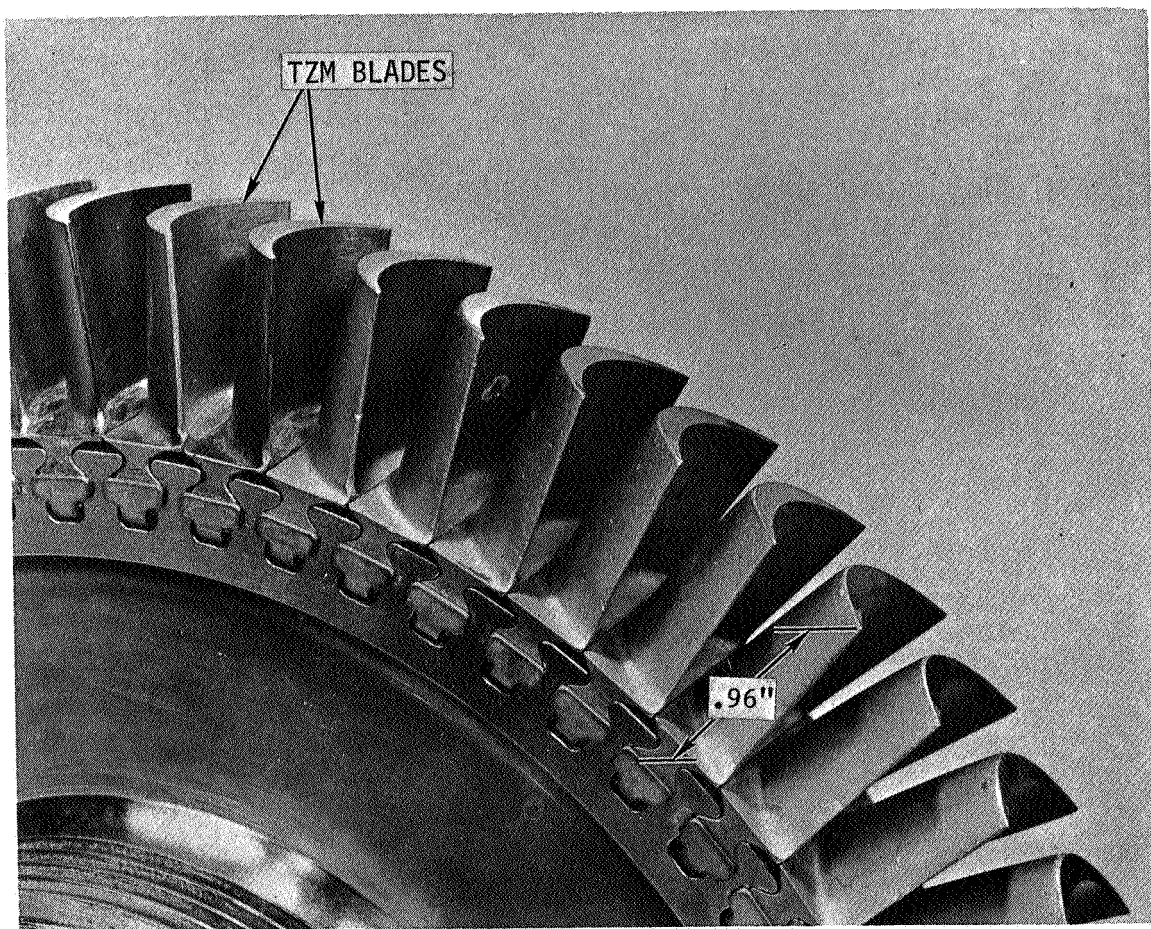
Figure 50. Second Stage Turbine Wheel Assembly After 2000 Hour Endurance Test, Vapor Blast Cleaning and Reassembly. (C6602215)

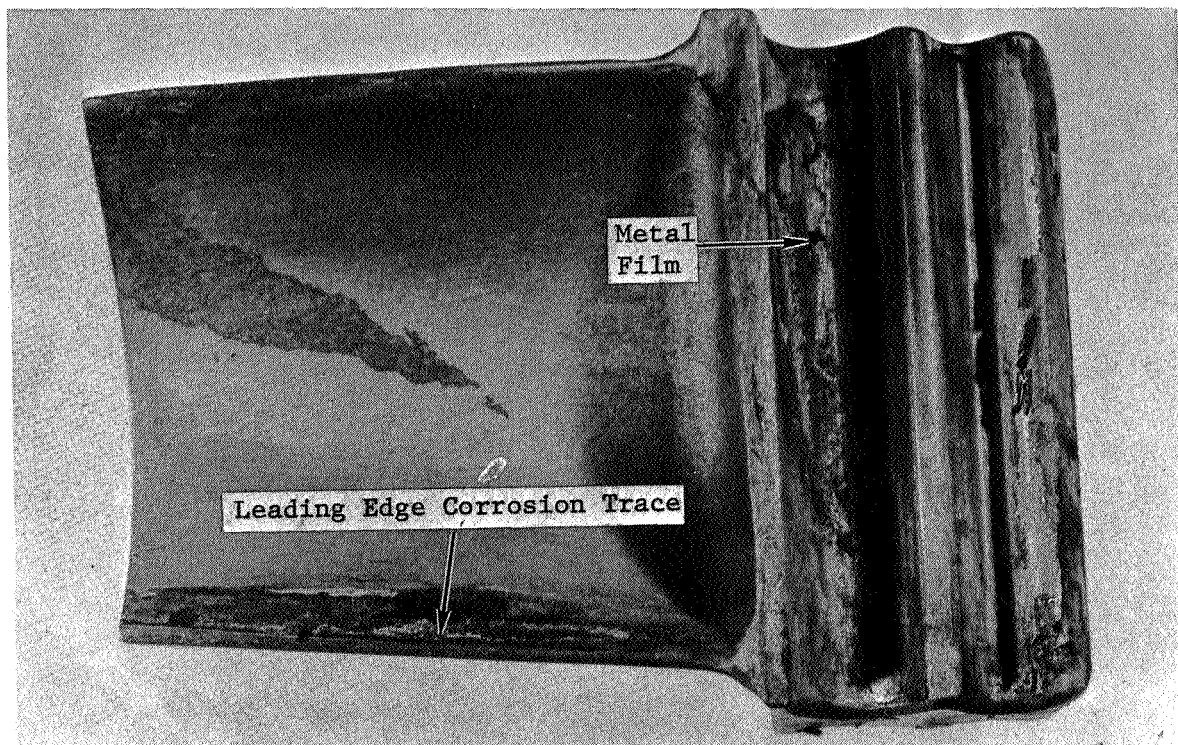
Turbine Blade Corrosion - The post-test appearance of the first stage U-700 turbine blades is shown in Figures 51 through 54 and that of the second

Figure 51. Concave Side of U-700 First Stage Turbine Blade After 2000 Hour Endurance Test. (C66011343)

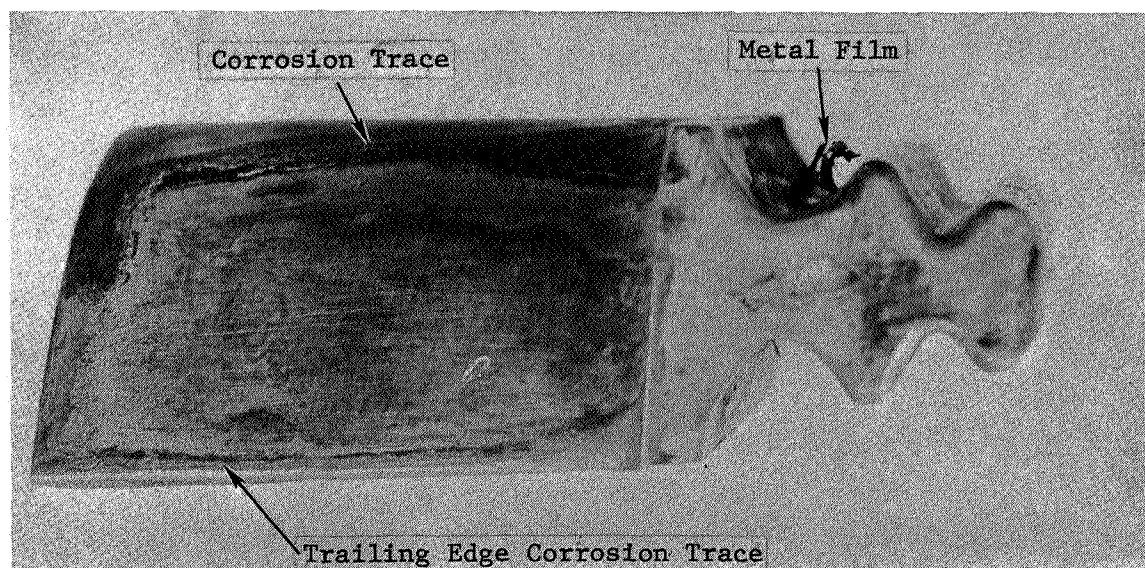
Figure 52. Trailing Edge of U-700 First Stage Turbine Blade After 2000 Hour Endurance Test. Note Metal Foil on Dovetail. (C66011340)
